Army Lodging Wellness Recommendation

Final Submittal - Hunter Army Airfield

March 17, 2004

Hunter Army Airfield

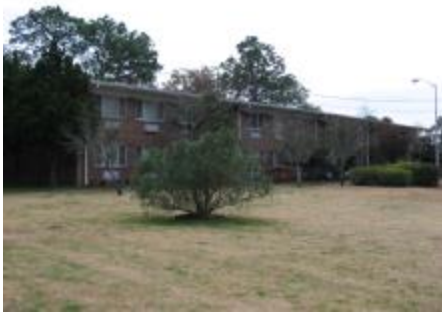
*Building 6005
525 Leonard Neal Street
Hunter Army Airfield, Ga. 31409*

Building 6005, constructed in 1959, is a 2-story brick facility housing 16 family suites and 8 extended stay guest rooms. Although this facility was renovated in 1981, it does not meet Lodging size requirements or provide appropriate support spaces. Based on the use of concrete masonry unit interior partitions, this building cannot be reconfigured without significant reconstruction. To renovate Building 6005 to the new standards and configuration will exceed 50% of the replacement cost.

Our recommendation is to remove building 6005 from the Lodging inventory, allowing the installation to determine an alternate use for this facility. This facility will be removed from the Hunter Army Airfield Wellness Solution and Lodging Master Plan.

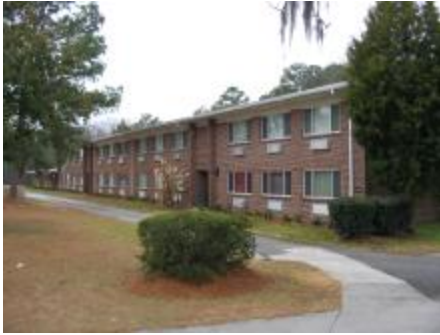
*Building 6010
525 Leonard Neal Street
Hunter Army Airfield, Ga. 31409*

Building 6010, constructed in 1959, is a 2-story brick facility housing 16 family suites and 2 extended stay guest rooms. This facility is the main Lodging Facility on the installation. Although this facility was renovated in 1981, the building does not meet Lodging size requirements or provide appropriate support spaces. Based on the use of concrete masonry unit interior partitions, this building cannot be reconfigured without significant reconstruction. To renovate Building 6010 to the new standards and configuration will exceed 50% of the replacement cost.
